# Debris/Ice/TPS Assessment And Photographic Analysis For Shuttle Mission STS-41

(NASA-TM-103814) DEBRIS/ICE/TPS ASSESSMENT  
AND PHOTOGRAPHIC ANALYSIS FOR SHUTTLE  
MISSION STS-41 (NASA) 151 p CSCL 22B

DEBRIS/ICE/TPS ASSESSMENT  
AND  
PHOTOGRAPHIC ANALYSIS  
OF  
SHUTTLE MISSION STS-41

October 6, 1990

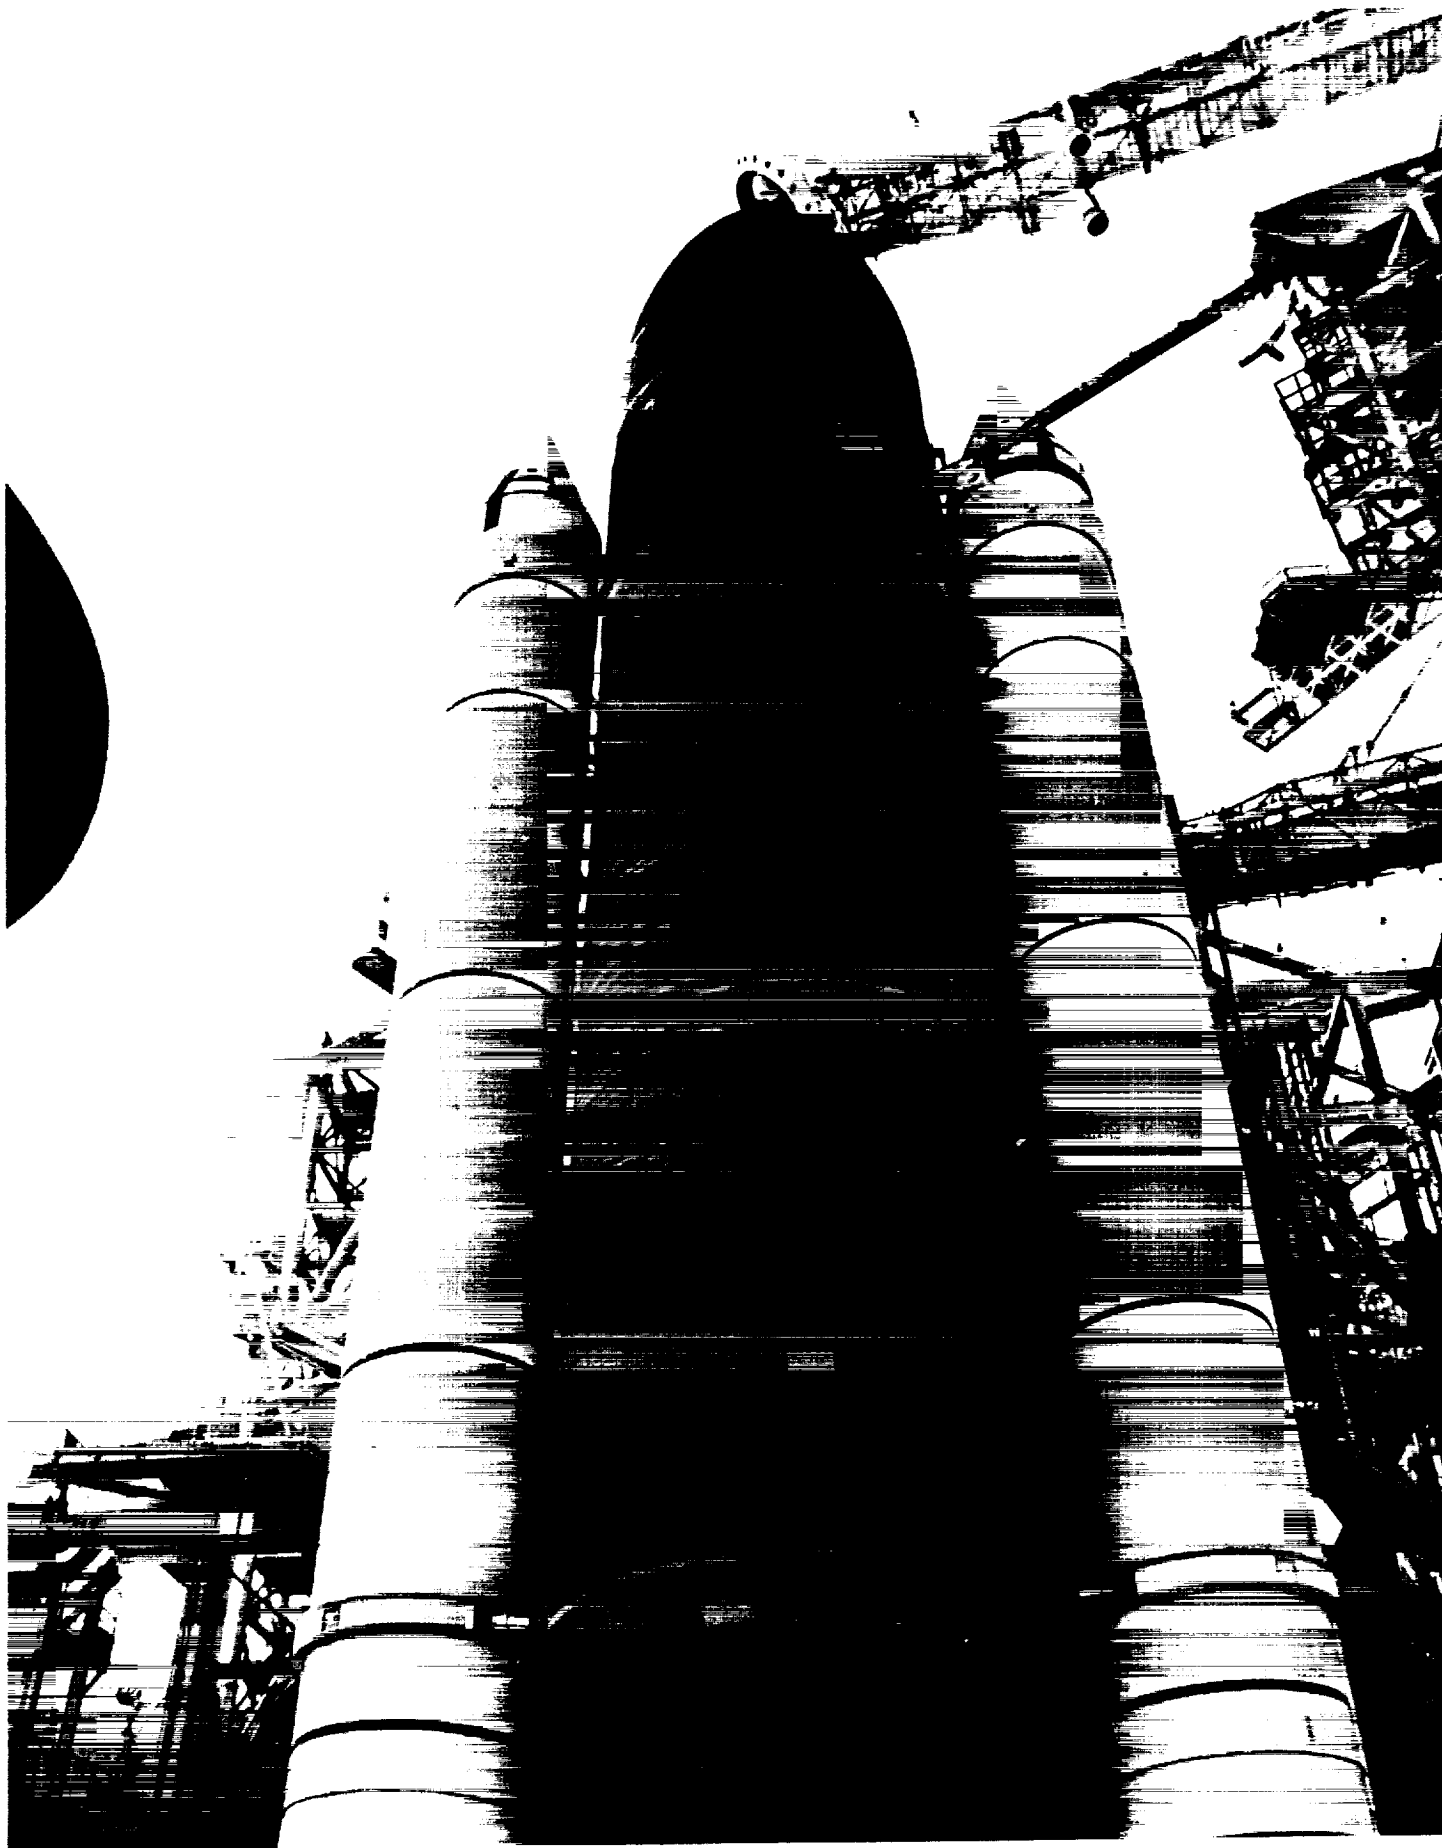
Overall view of ET-39 (LWT 32) and BIO40 -Z side

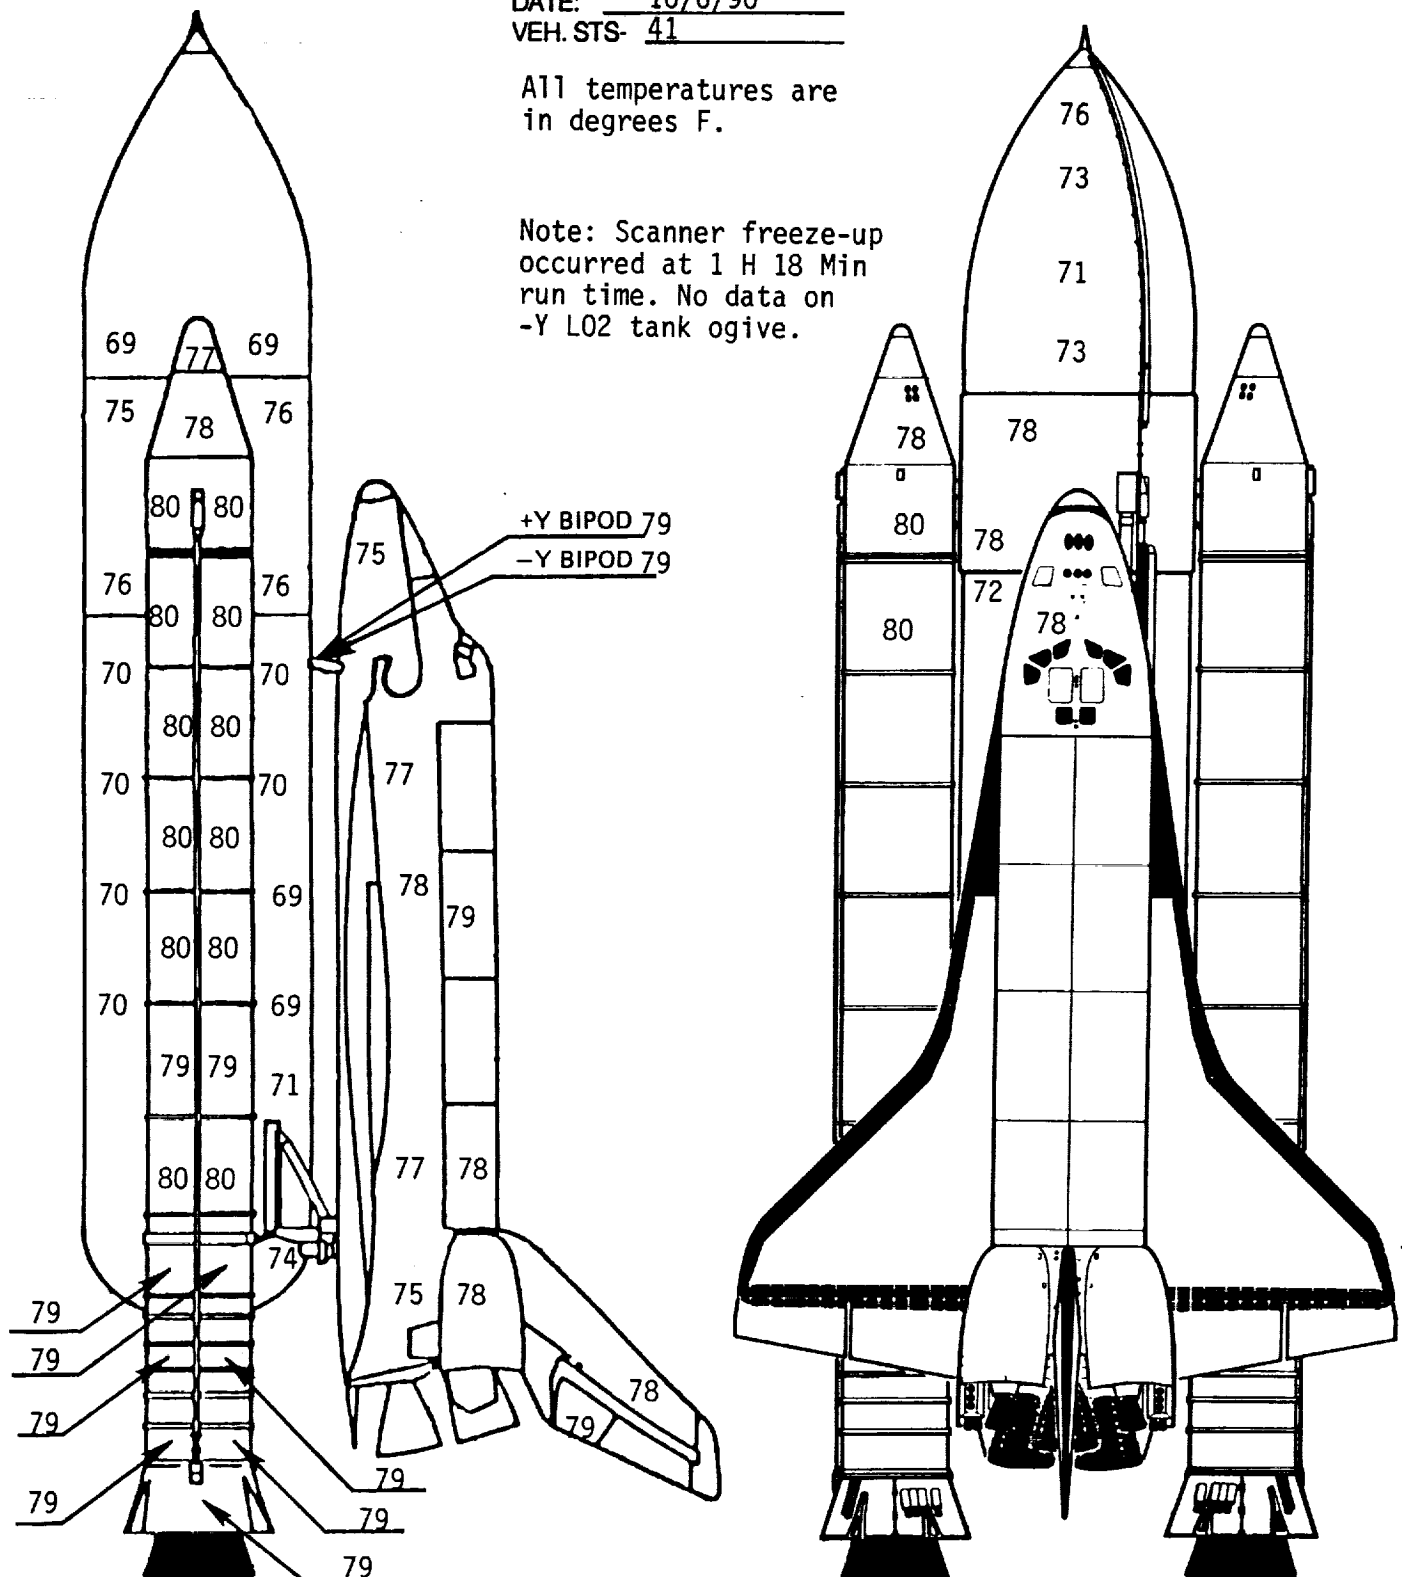
FIGURE 2. **SSV INFRARED SCANNER  
SURFACE TEMPERATURE  
SUMMARY DATA**

Note: Scanner freeze-up occurred at 1 H 18 Min run time. No data on -Y L02 tank ogive.

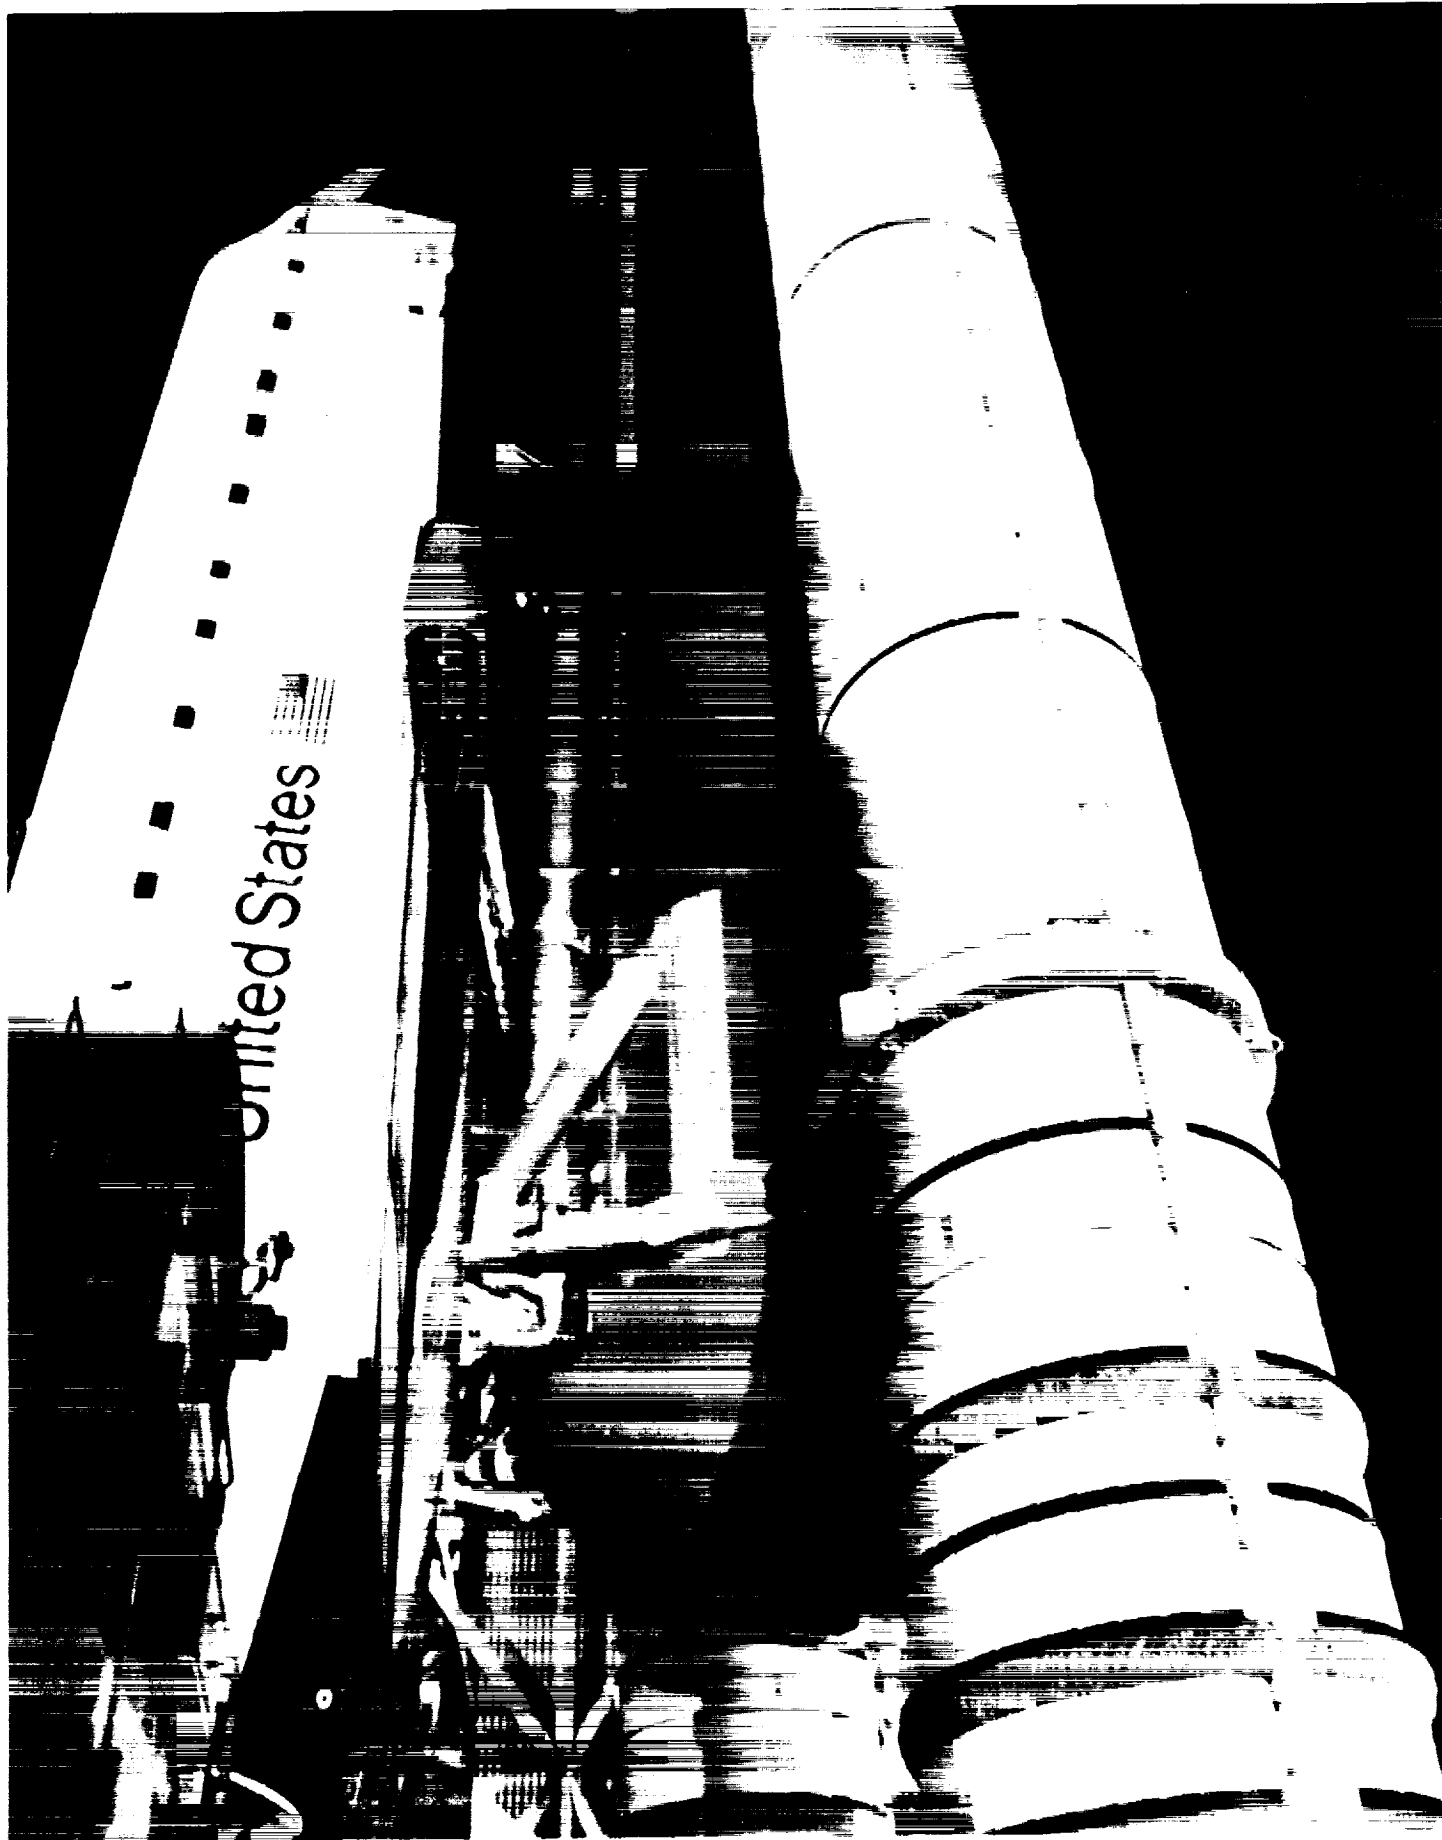
Overall view of SSV after cryoload stable replenish. There was no ice/frost accumulation on the LH2 tank acreage.

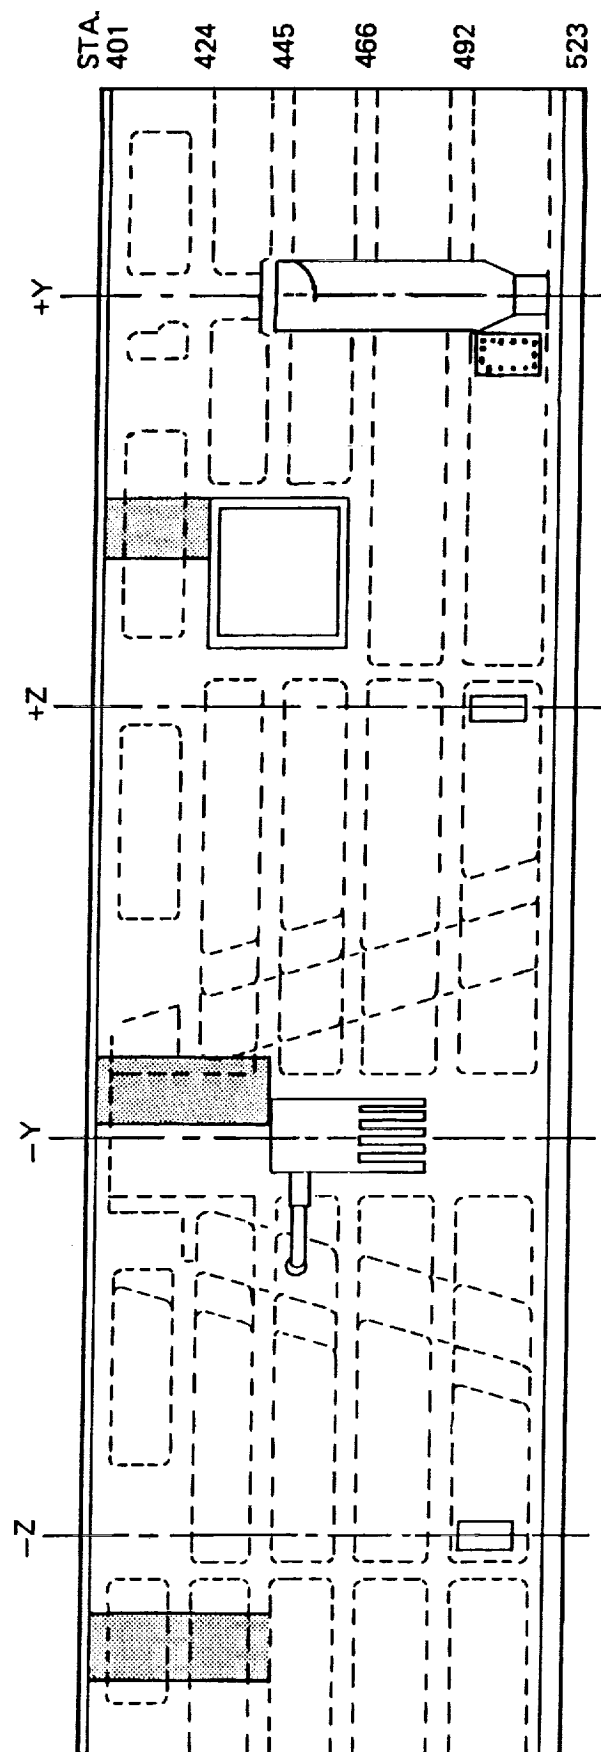
FIGURE 6. RIGHT SRB FWD SKIRT

The RH forward skirt exhibited no debonds or missing TPS (Figure 6). The frustum severance ring, which utilized the new pin retainer clips, was missing no pins. Separation of the forward attach bolt appeared normal.

TPS MISSING  
NONE

DEBONDS  
NONE

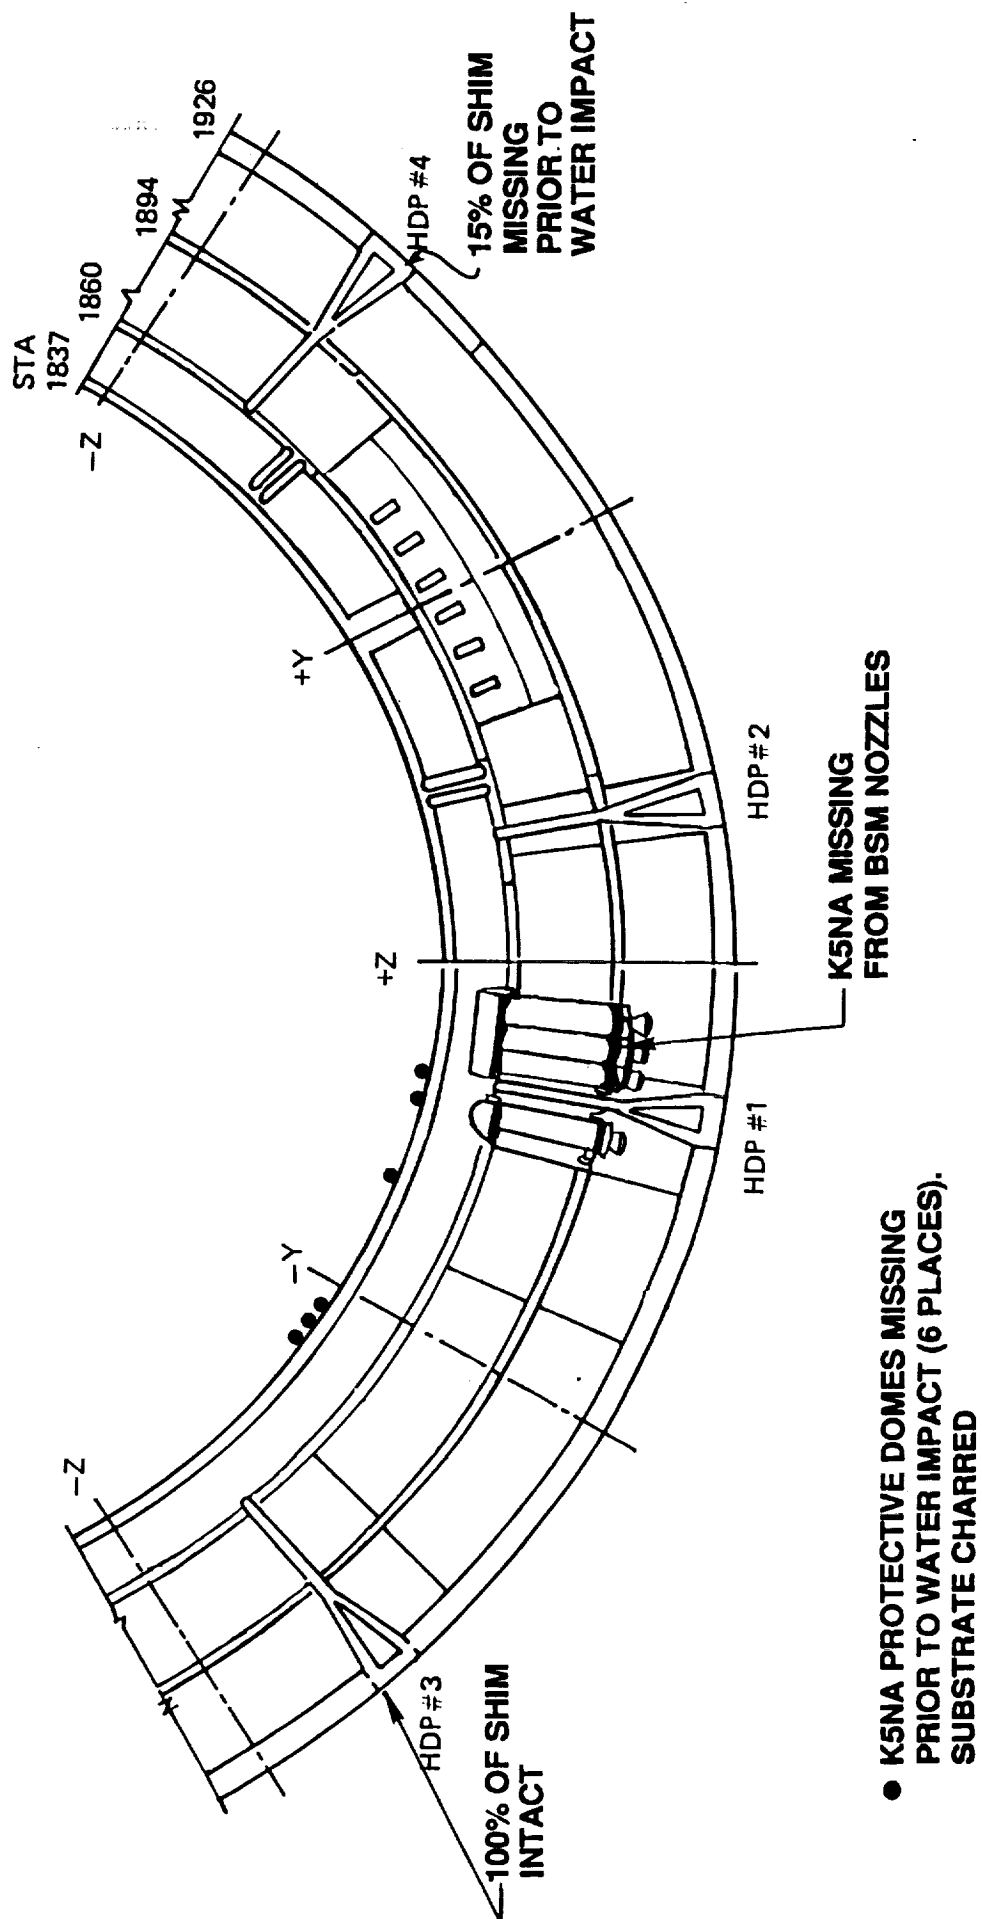
FIGURE 7. RIGHT SRB AFT SKIRT EXTERIOR TPS

The phenolic material on the kick ring delaminated in several locations. K5NA protective domes on the aft side of the phenolic kick ring were missing in 6 places (220-270 degrees) prior to water impact. All four Debris Containment System (DCS) plungers were properly seated (Figure 7).

1. BLISTERING OF HYPALON PAINT OCCURRED IN GENERAL AREA OF THE THRUST POST.

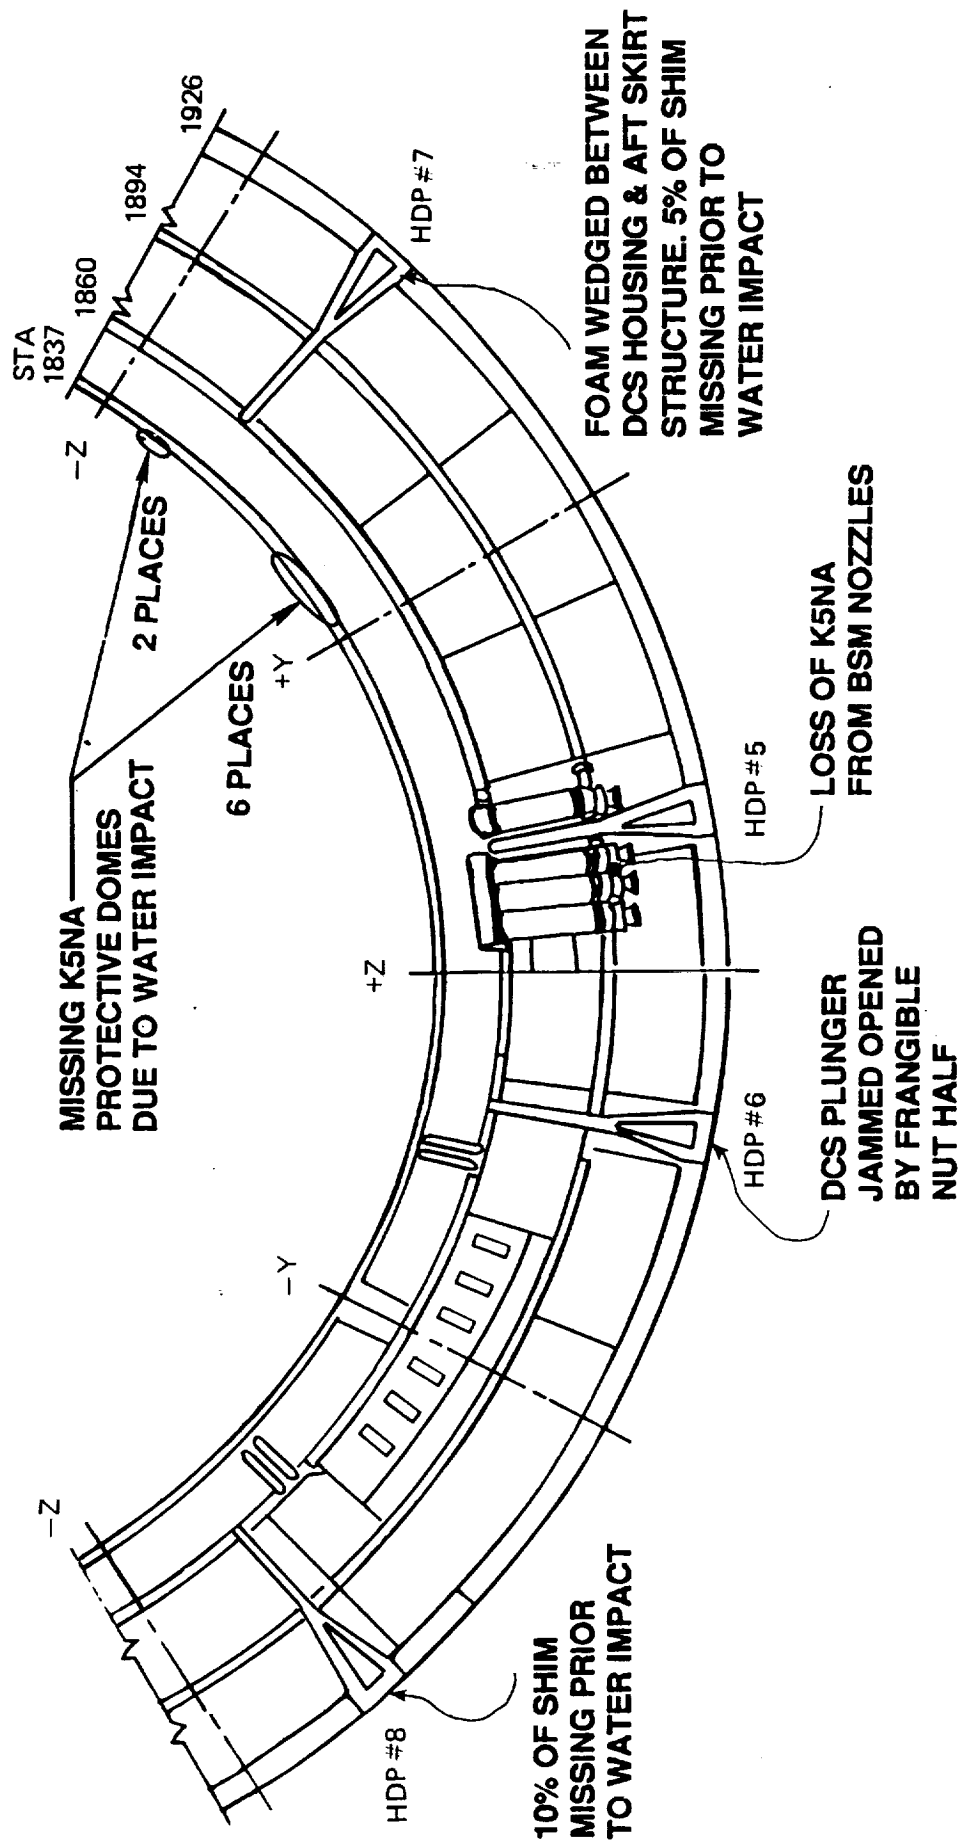
FIGURE 10. LEFT SRB AFT SKIRT EXTERIOR TPS

The phenolic material on the kick ring delaminated in several locations. HDP #5, 7, and 8 DCS plungers were properly seated. The HDP #6 plunger was jammed open by a frangible nut half. Aft skirt HDP #7 was missing Epon shim from the inboard side of the foot and the substrate was sooted (Figure 10).

1. TYPICAL BLISTERING &  
SOOTING OF HYPALON PAINT

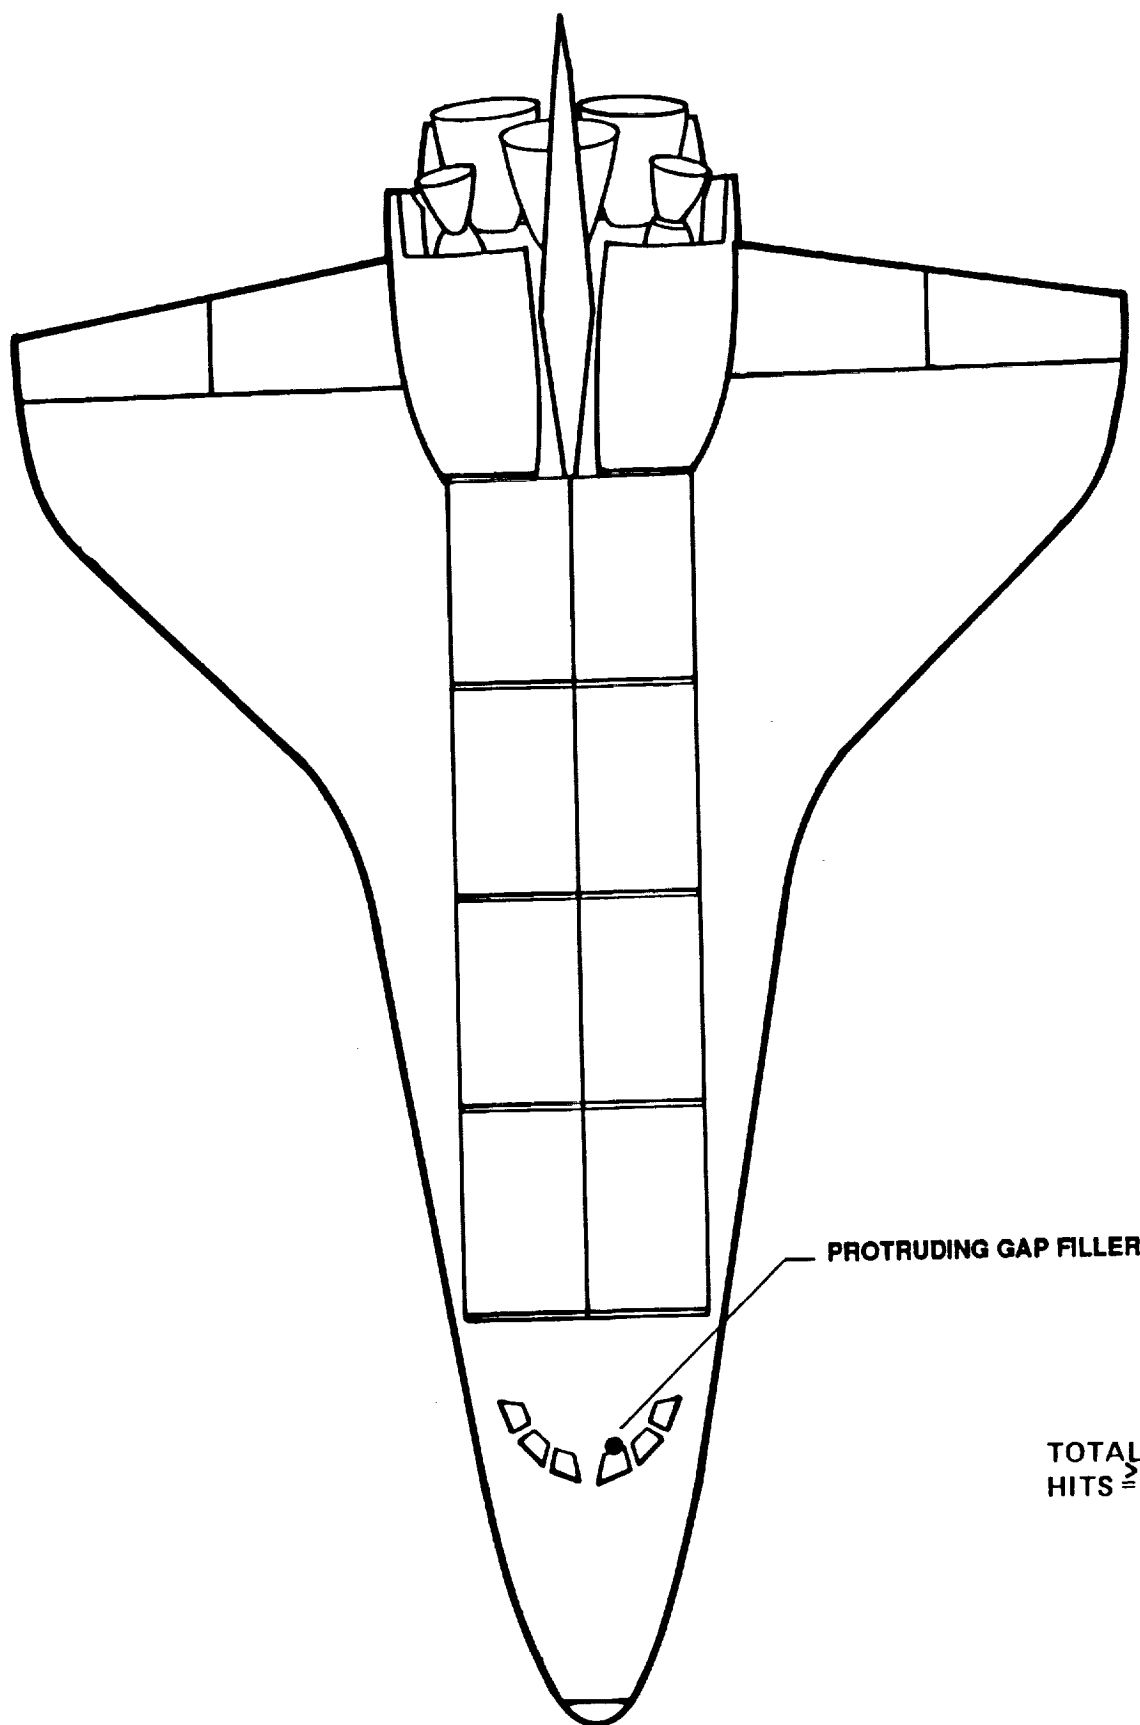
FIGURE 14. DEBRIS DAMAGE LOCATIONS

TOTAL HITS = 1  
HITS  $\geq$  1 INCH = 0

Several small pieces of gap filler sleeving material were protruding slightly on the leading edges of both RH and LH OMS pods. No apparent damage to adjacent tiles resulted from these gap fillers. The overall condition of the OMS pods was better than usual with only one debris damage site on the LH OMS pod.

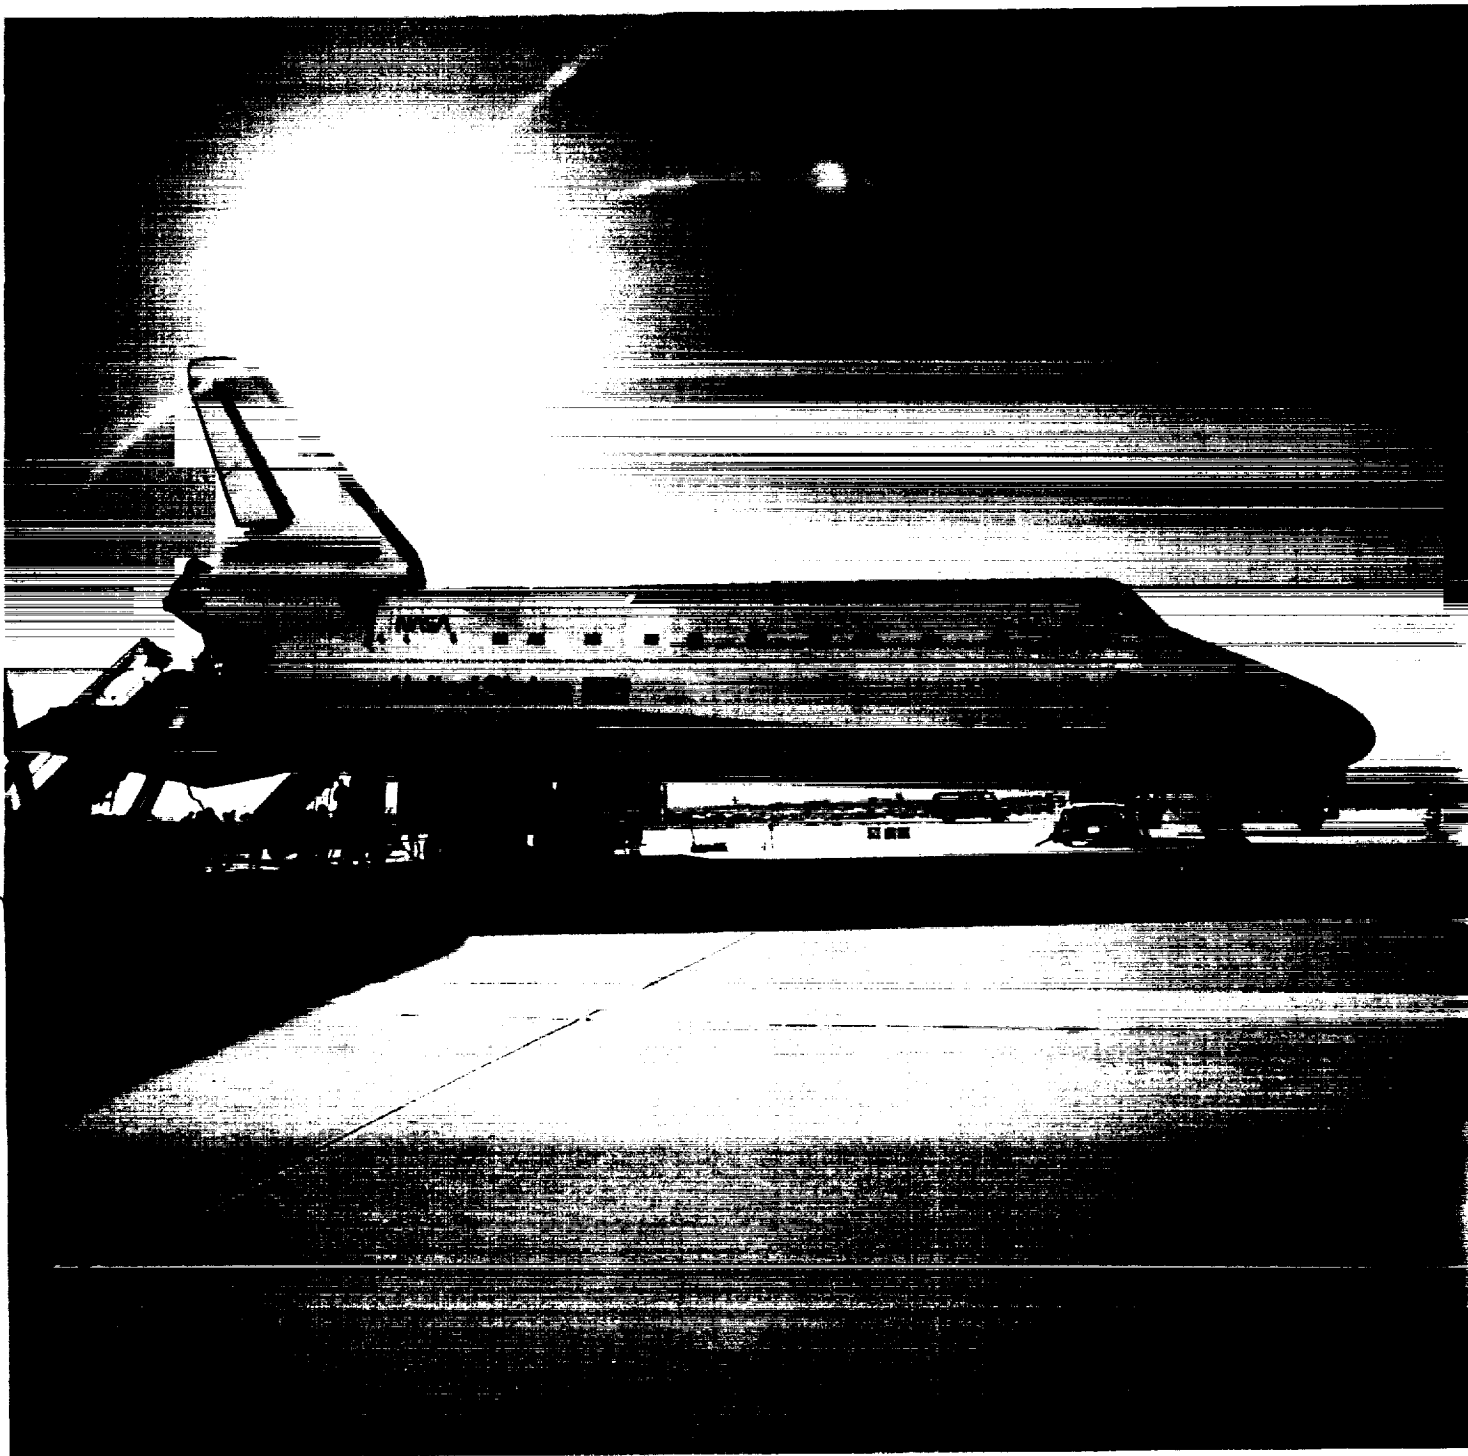
Overall view of OV-103 RH side after landing

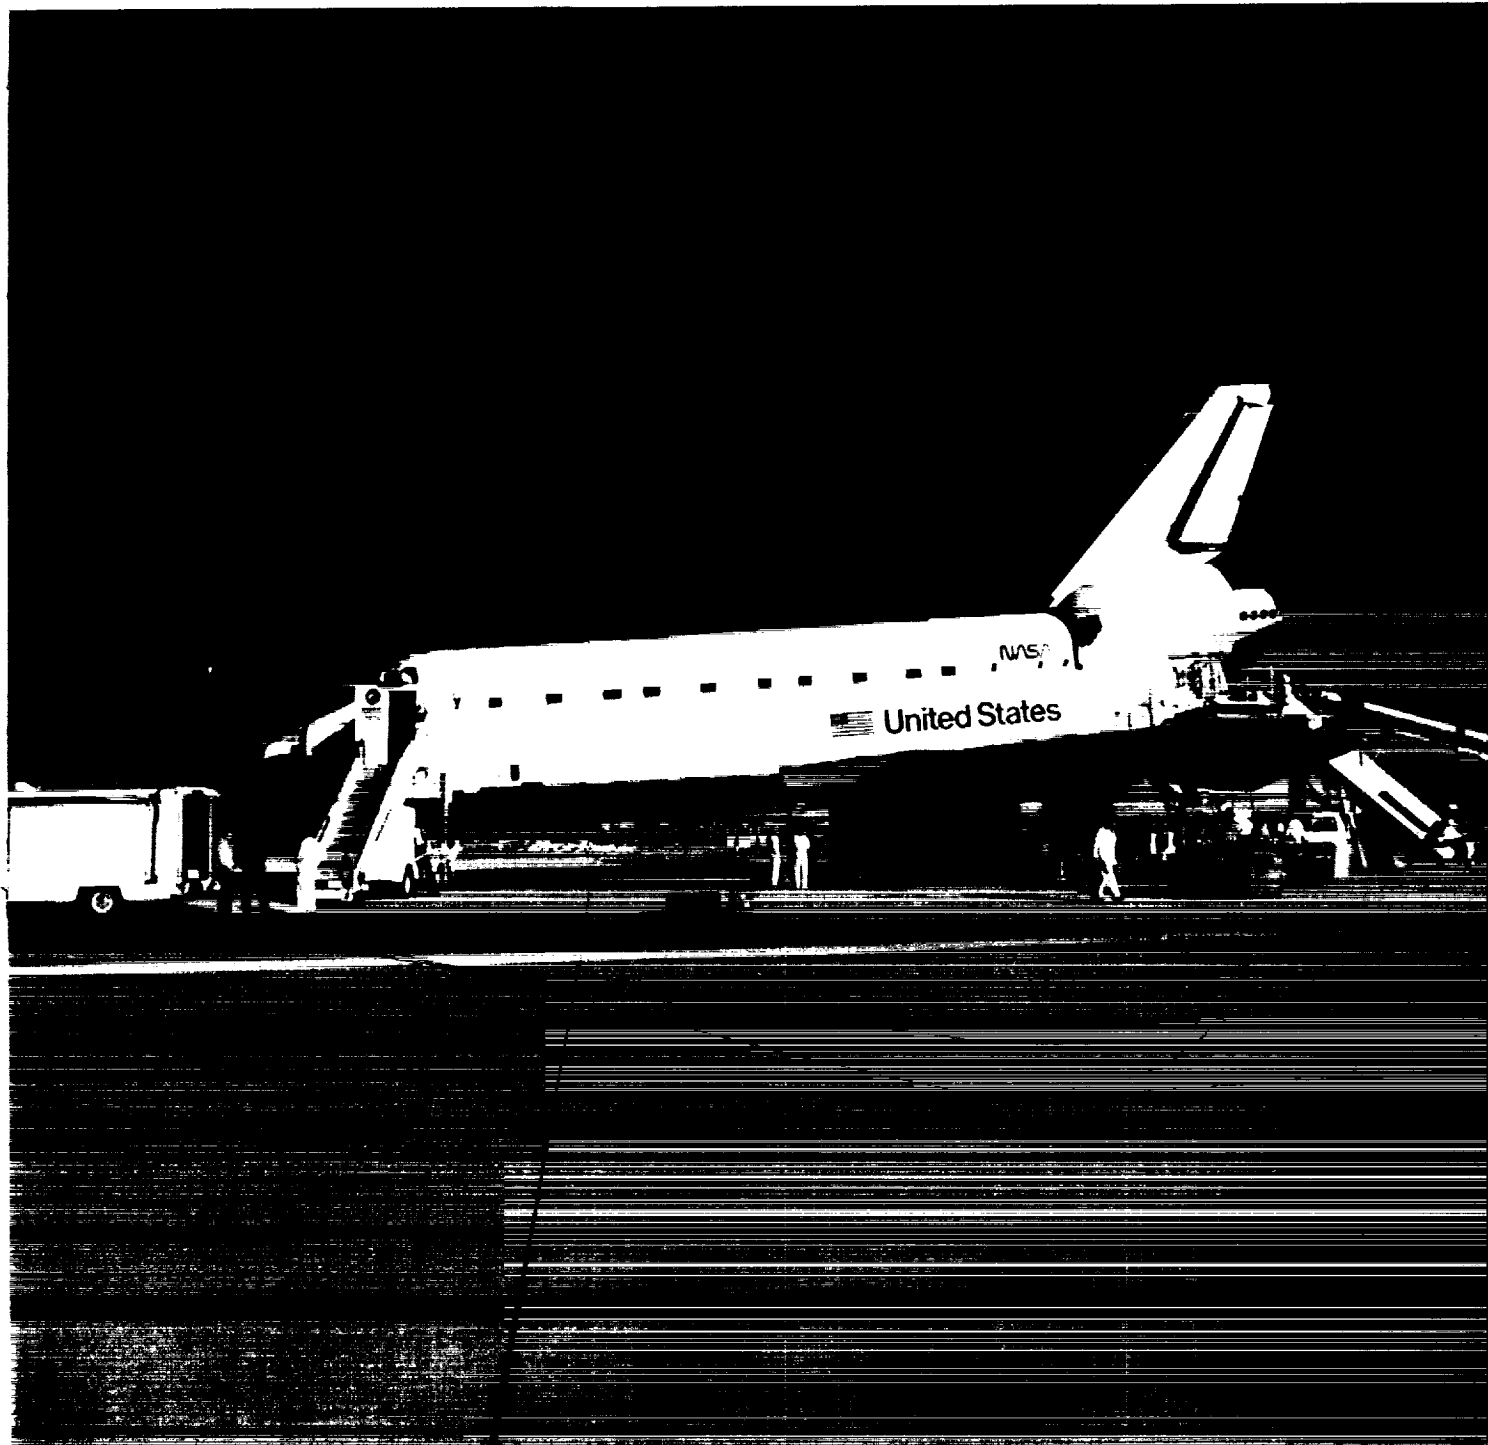
Overall view of OV-103 LH side after landing

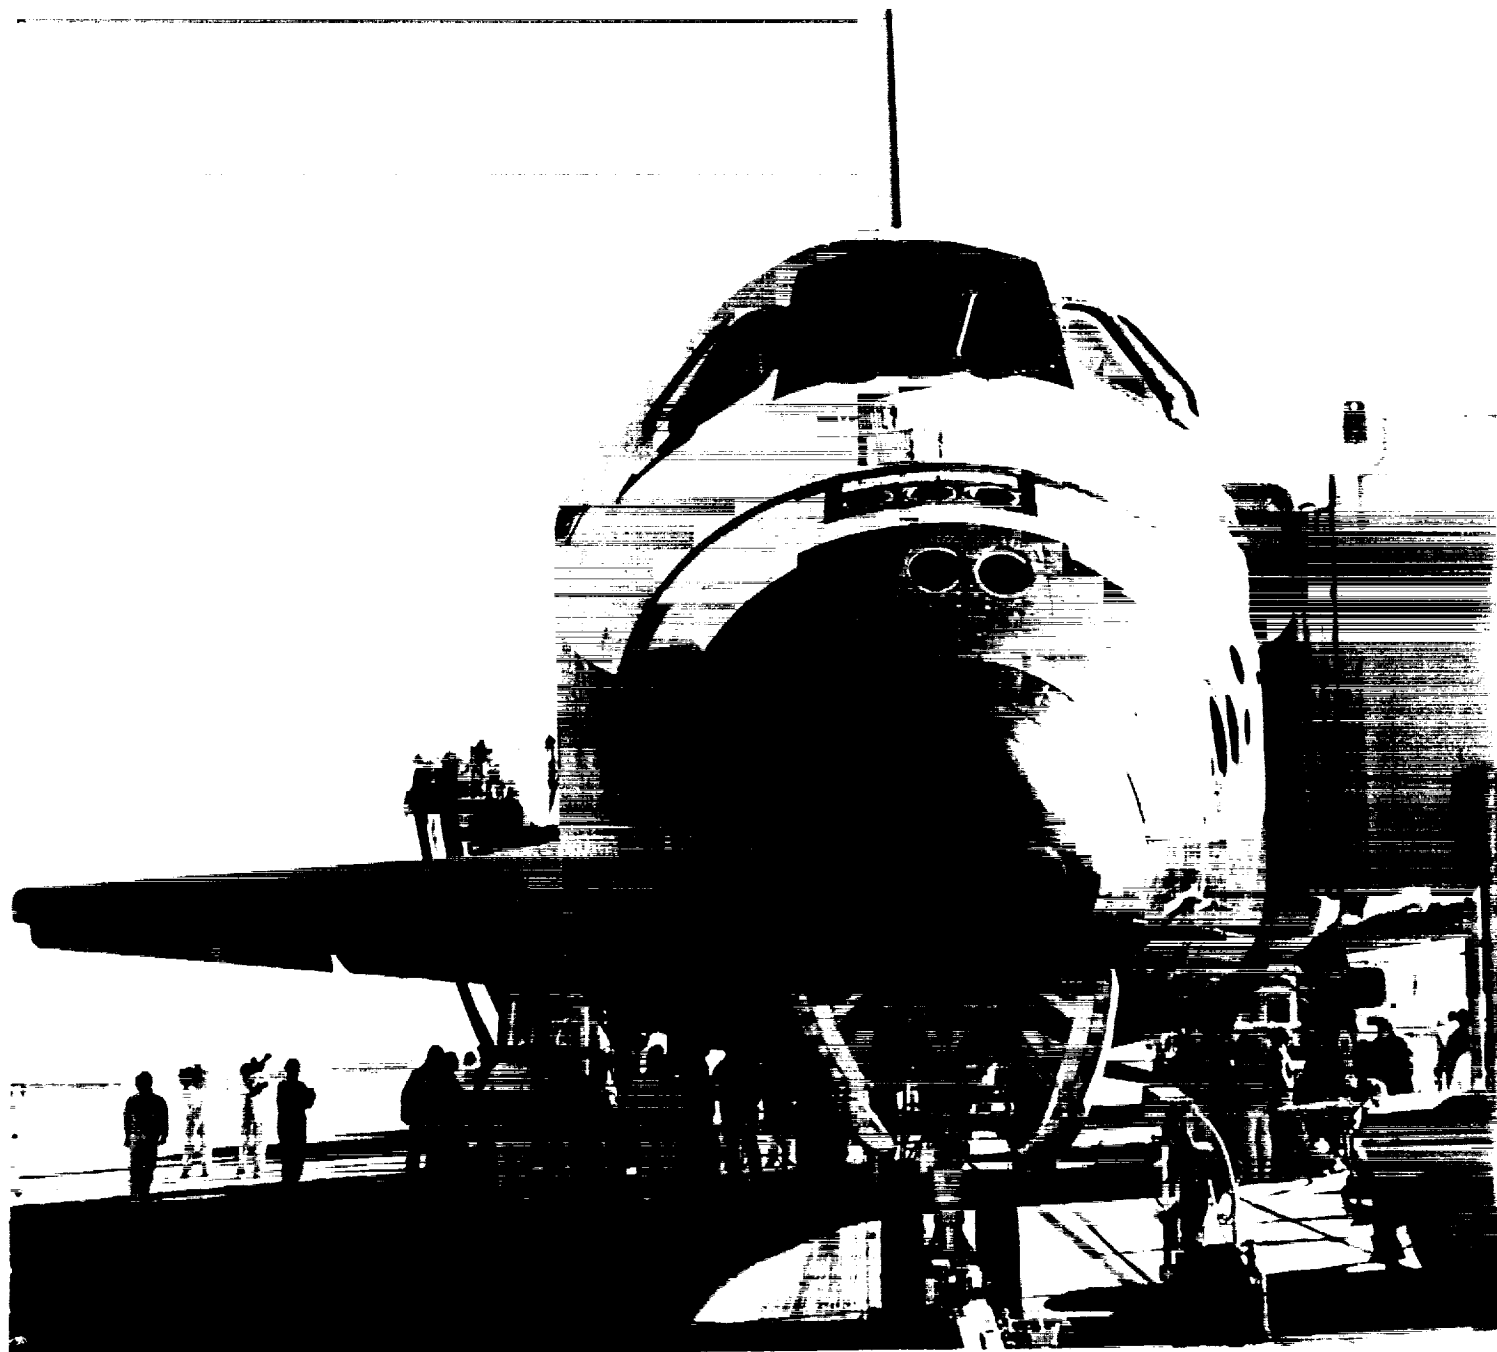
Post landing condition of OV-103 nose tiles and windows

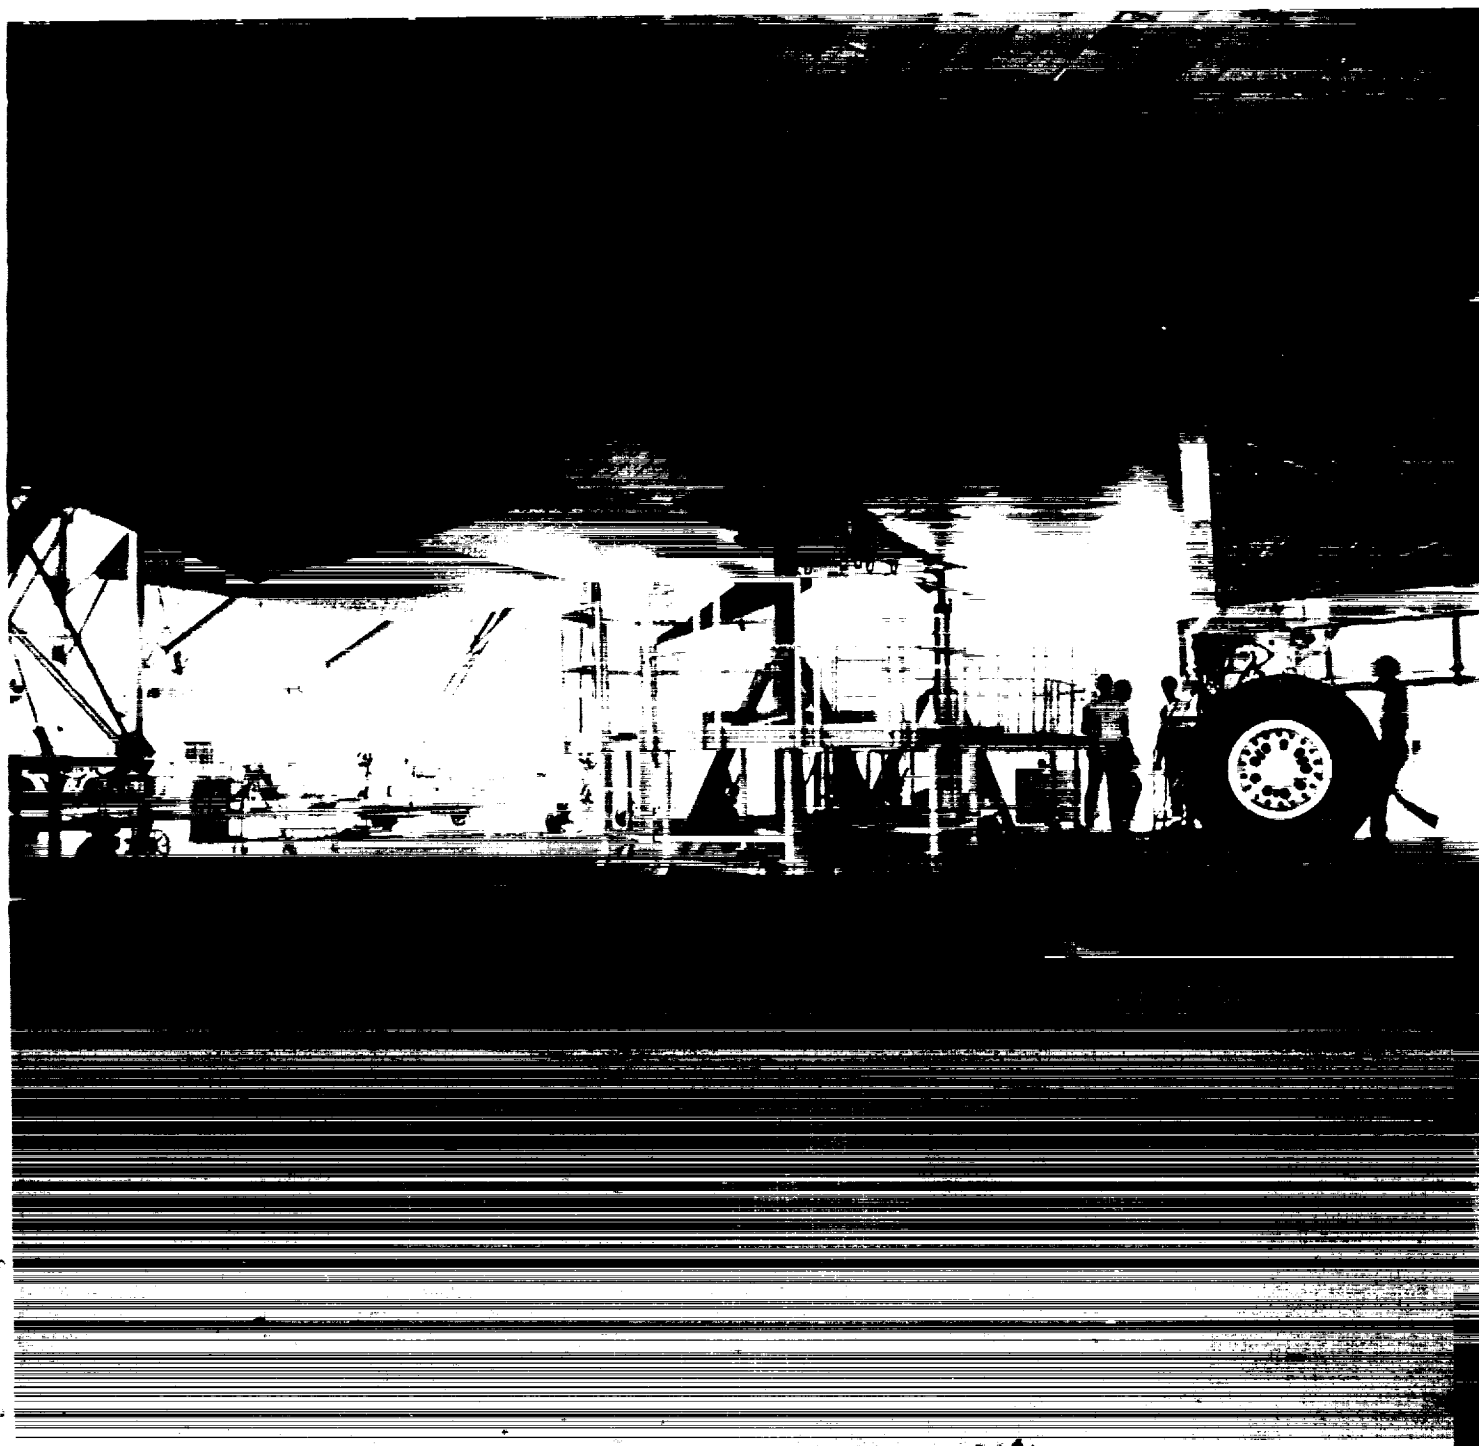
Overall view of Orbiter RH wing lower surface/elevons
